NORCO INDUSTRIES APPROVED INSPECTION PROCEDURE

STEP 1: VISUAL INSPECTION

NORCO INDUSTRIES APPROVED REPAIR PROCEDURE**STEP 2: REPAIR IF VISUAL INSPECTION FAILS**

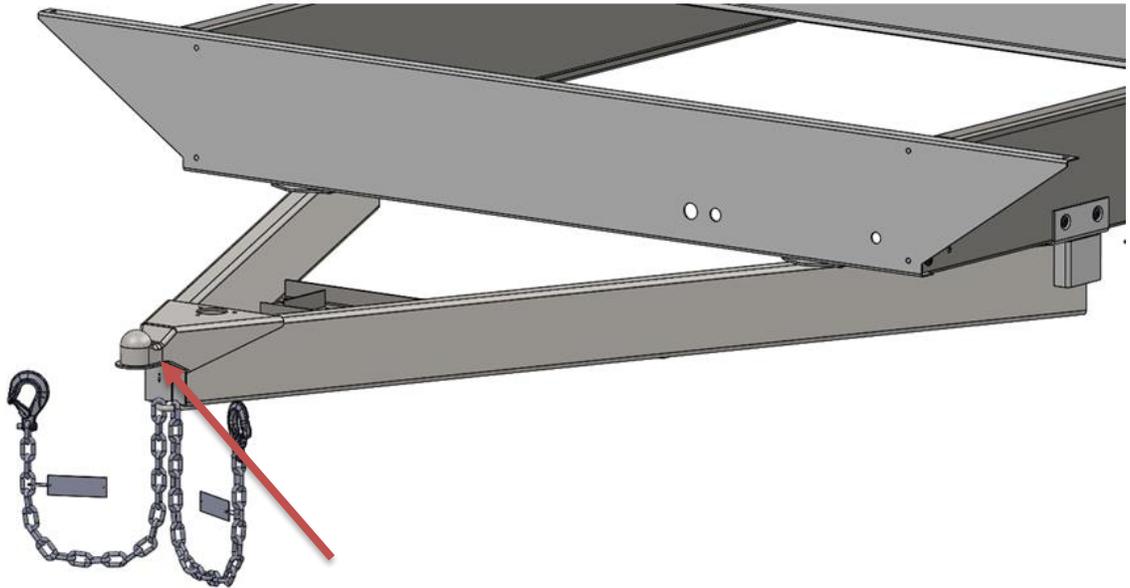
- 1) Inspection location: Bottom side of coupler located at the front end of the a-frame.

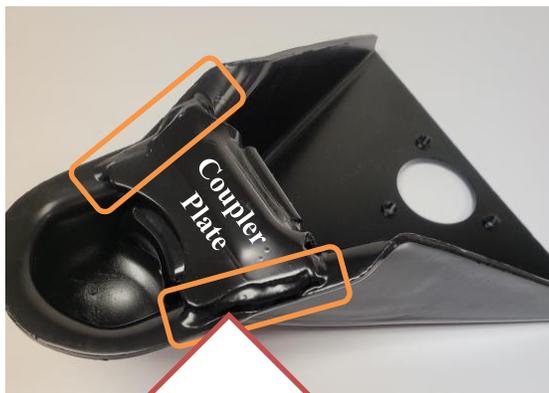
PASS (Painted View)

- 2) Underneath the coupler, use a flashlight to inspect the welds at each side of the bottom coupler plate.
a. To Pass Inspection: A weld bead should run along each side of the plate.
b. To Fail Inspection: A weld bead will not run along the side of the plate and there will only be tack welds
